Field Test Report

23.5R25 ECOMEGA M5DLX L5 2**TL

LATEST INSPECTION DATE

03/07/2015

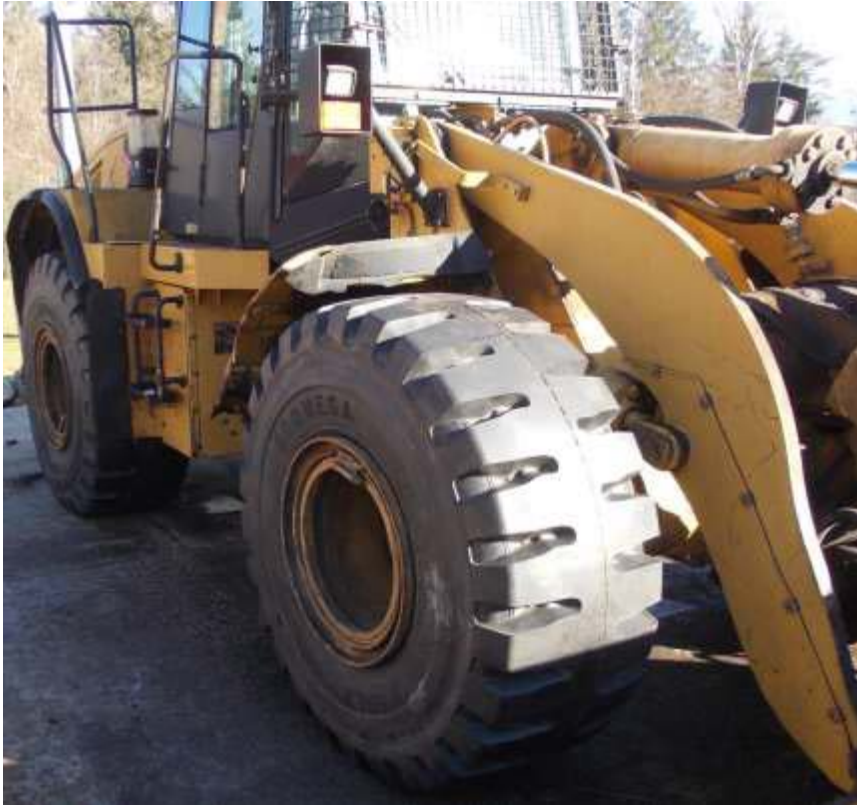
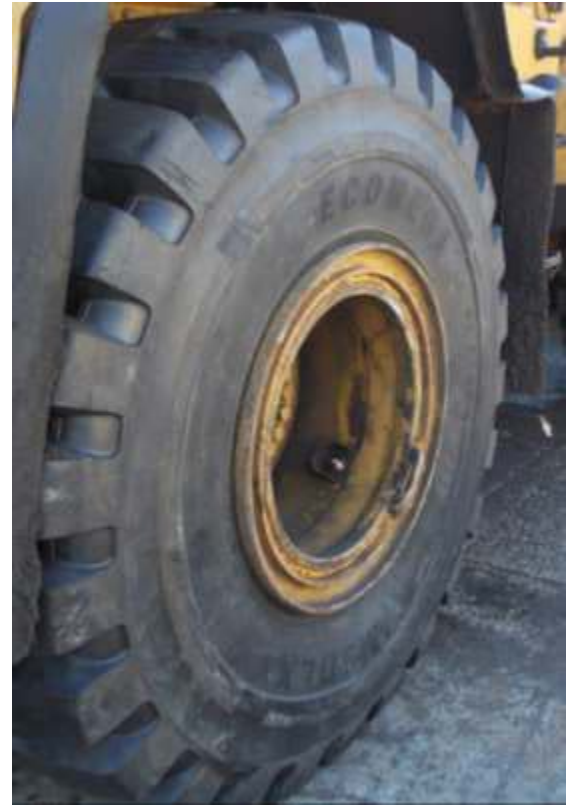
CASINGS LOOK VERY NICE AT THE END OF THEIR LIFE
3 SHIFT PER DAY WITH HIGH TEMPERATURE AND STRESSFUL WORK/APPLICATION

CASINGS HAVE BEEN SUCCESSFULLY REMOULDED WITH L5 XMINE PROFILE
CUSTOMER WAS VERY SATIFY AND REPLACED THESE TIRES WITH OTHERS ECOMEGA M5DLX
